Manhole Inspection Summary

Manhole # S17YY_009MH

Insp Date: **3/2/07 11:05 AM**

Location Address: **3404 COTTONWOOD PL**

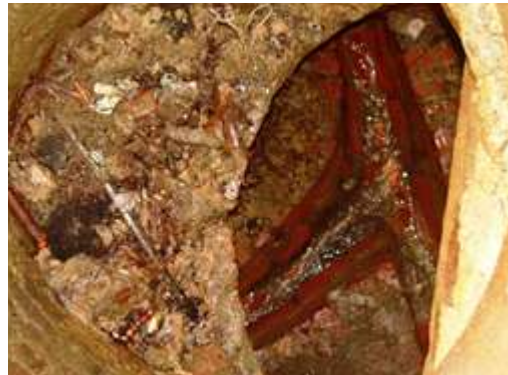
Top View

Evidence of surcharge - Bench debris.

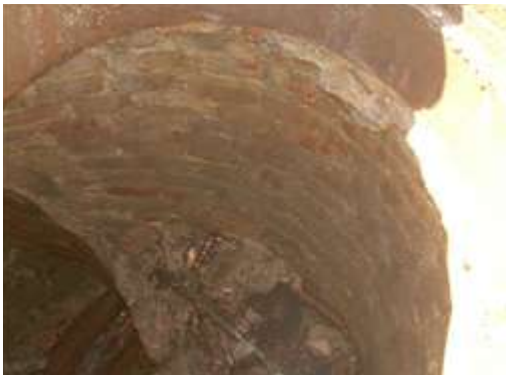
Defect

☒ **Leaks**

Condition: ☐ Sound ☐ Cracked ☐ Root Intrusion ☐ Loose Brick ☒ **Deteriorated**

Infiltration: ☐ None ☒ **Joint** ☐ Cracks ☒ **Mortar** ☐ Roots ☐ Wall

Infiltration: ☐ None ☐ Joint ☐ Cracks ☒ **Mortar** ☐ Roots ☐ Wall

Frame leaks. Adjustment deterioration and infiltration. Barrel infiltration.

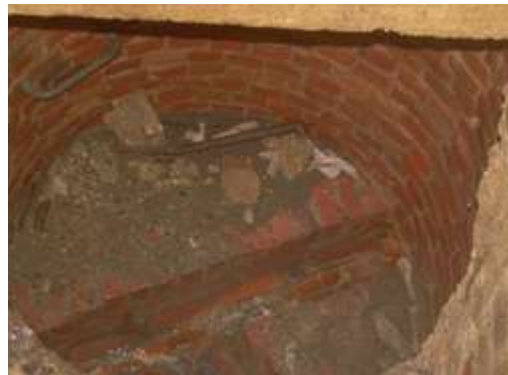
Defect 2

☒ **Evidence Of Surcharge**

Depth: **2** (ft.)

Evidence of surcharge - Bench debris.

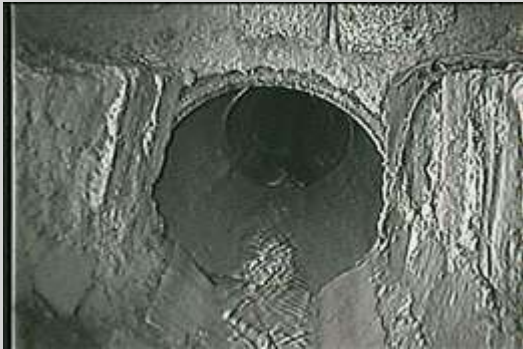
8 in. Circular Gravity Sewer Pipe Out @ 12 O'Clock

Infiltration: **Evidence** Pipe Seal Cond: **Unknown**

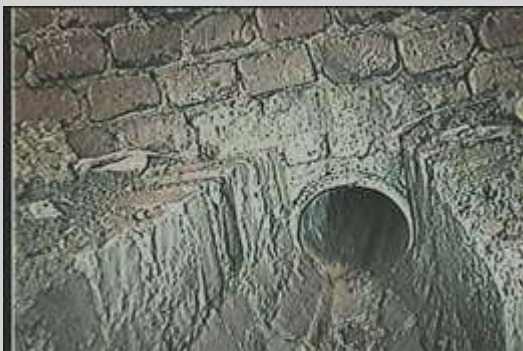
6 in. Circular Gravity Sewer Pipe In @ 6 O'Clock

Barrel deterioration and infiltration.

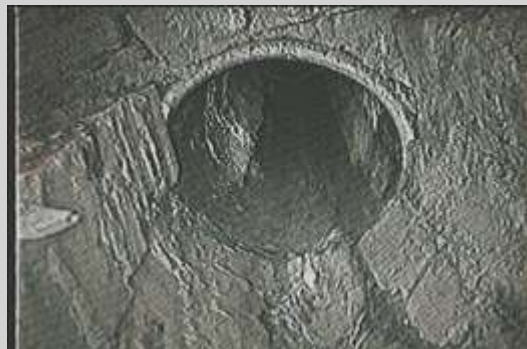
8 in. Circular Gravity Sewer

Channel deterioration.

Deposits: ☐ None ☐ Mud ☐ Sludge ☐ Debris ☒ **Grease**

Deposits Extent: **Light**
